Factors Contributing to Poultry House Structural Failures

*Dr. Sid Thompson, Michael Czarick and Dr. John Worley
Biological and Agricultural Engineering Department*

Bulletin 1391

September 2014

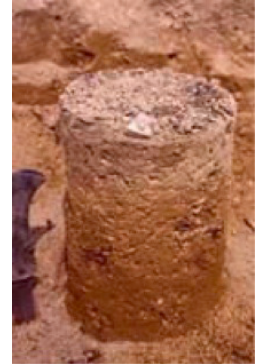
Figure 1. Column of soil.

A freestanding column of soil such as the one in Figure 1 cannot stand on its own if loaded vertically. While soil can carry a load, a freestanding column of soil fails when loaded. As it fails the column will get shorter and wider. Even though the column of soil is only loaded vertically, lateral (horizontal) forces occur within the soil that make it wider.

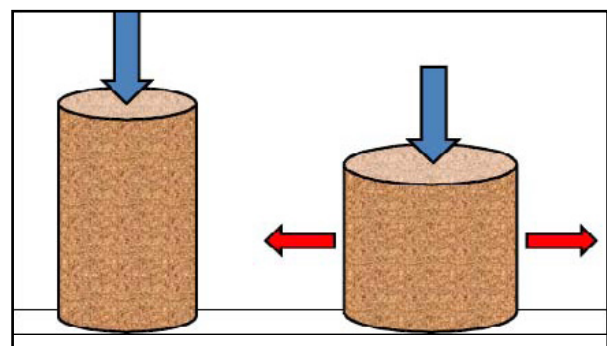
Figure 2. Loaded, unsupported soil column.

If this same column of soil is placed within a container, then the column can carry a larger vertical load. The container walls keep the soil confined within the container and help carry the lateral (horizontal) loads that occur within the soil.

A building transfers loads throughout the structure to the foundation, which then transfers the load to the soil directly beneath the foundation. Like the column of soil in Figure 2, the soil directly

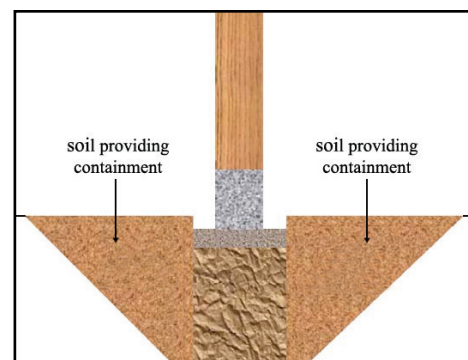
Figure 3. Soil next to a foundation providing “containment” of the soil column under the foundation.

beneath the foundation can only carry these loads if it is properly confined. The confinement in this case does not come from a container but rather from the adjacent soil (Figure 3). It is normally assumed that a triangular block of soil helps confine the soil directly beneath the foundation.

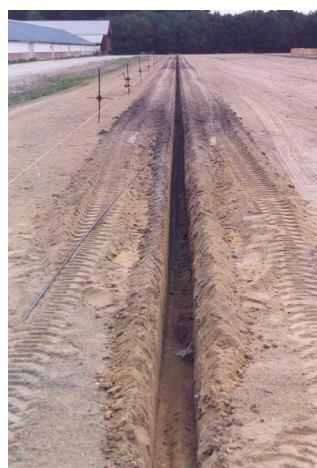
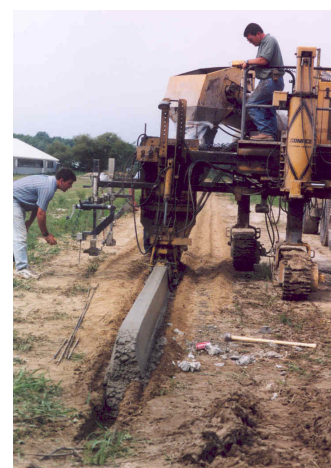
Figure 4. Foundation trench.

The minimum depth of a poultry house foundation below ground level is generally 12 in. or below the frost line, whichever is greater (Figure 4). The depth of the foundation is measured from the surface of the undisturbed ground to the bottom surface of the foundation. In the case of poultry houses with concrete “stem walls,” the stem wall is the foundation and therefore the bottom of the wall should extend a minimum of 12 in. below the soil surface.

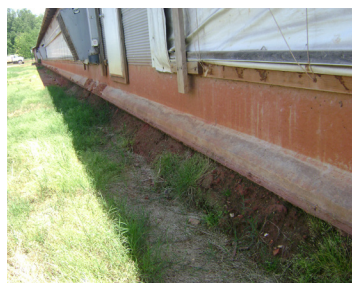
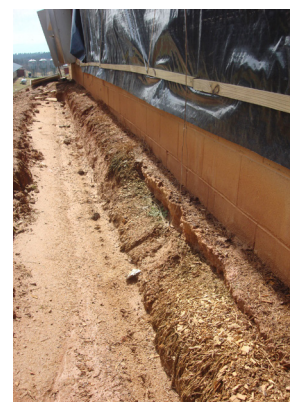
Figure 5. An exposed foundation due to erosion.

Foundations that are near or above grade can be easily undermined by erosion, rodents or even birds. Once a foundation is undermined the structural integrity of the poultry house is compromised (Figure 5).

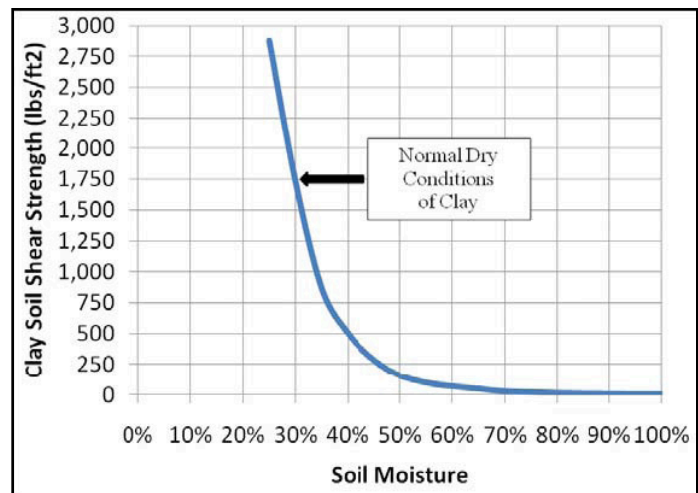
Figure 6. Clay soil shear strength as a function of percent moisture.

Saturated soil has little strength to support a poultry house foundation in either the vertical or horizontal directions, thus allowing movement. Figure 6 illustrates the shear strength (bearing capacity) of clay soil as a function of percent soil moisture. Under normal moisture conditions, clay soil is capable of supporting a load of roughly 1,800 pounds per square foot. But as clay soil moisture levels increase, the bearing capacity of the ground underneath the foundation decreases rapidly. If the soil in the immediate vicinity of a poultry house is chronically saturated with water, a foundation will be more prone to settling and rotational issues that can lead to a structural failure (Figure 7). As a result, it is important that the soil around a foundation be well drained. Foundation drainage can be aided through the use of foundation drains, permeable soils or rock.

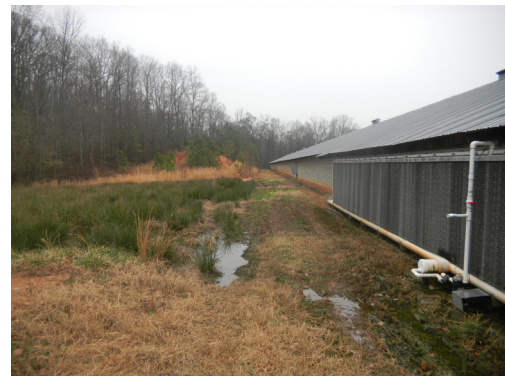
Figure 7. Standing water can lead to foundation problems.

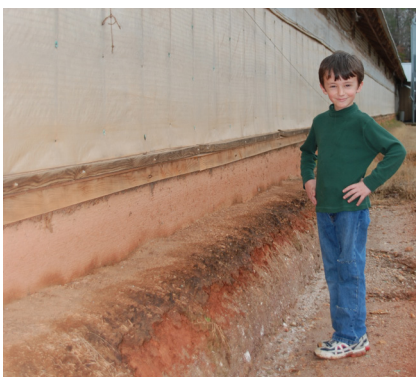
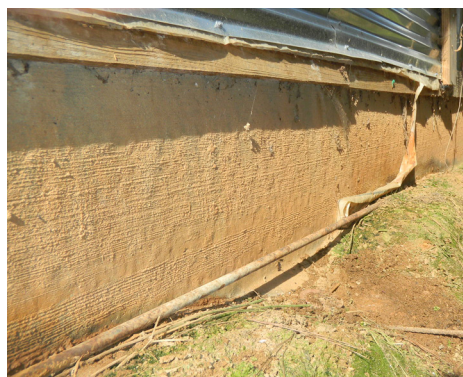
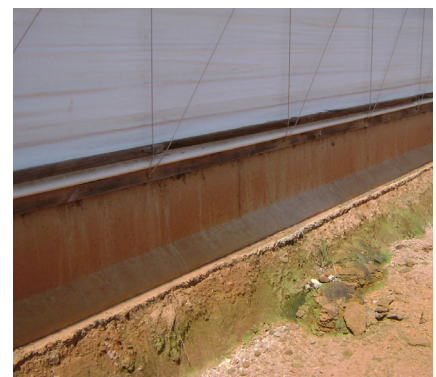
Figure 8. Examples of foundations undermined by erosion.

The bottom portion of a poultry house foundation must remain covered with soil (Figure 8). The ground around a poultry house should slope gradually (i.e., 1/12) away from the side wall to help direct water from the roof away from the foundation. It is generally recommended that the horizontal distance from the edge of the foundation to the face of any steep slope (3/12+) be a minimum of 5 ft. For steep slopes, rock may be required to prevent erosion.

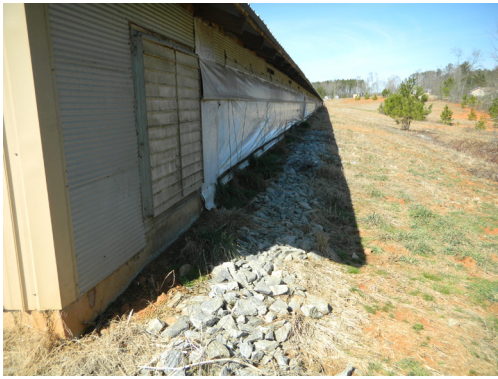
Figure 9. Rocks to prevent scouring.

The ground in the vicinity of the foundation should be protected from scouring due to rainwater flowing off the roof of the poultry house through the use of vegetative ground cover, rocks or gutters (Figure 9). Over time, scouring can lead to the erosion of soil near the house foundation, thereby effectively reducing foundation depth or possibly undermining the foundation. When scouring has occurred it is important that proper grade is reestablished as soon as possible to prevent foundation movement.

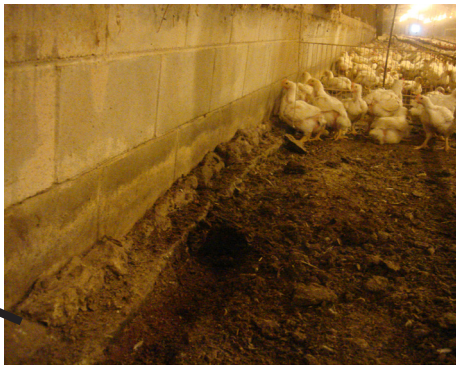
Figure 10. Interior Erosion: Soil should be added to maintain structural integrity.

An interior foundation depth of 8 to 12 in. must be maintained in order to maintain proper vertical and lateral support. Differences between interior and exterior grades can result in uneven loads being applied to the foundation, which can lead to foundation rotation (Figure 10). When cleaning out, the foundation must be protected from damage and undermining due to excessive soil removal.

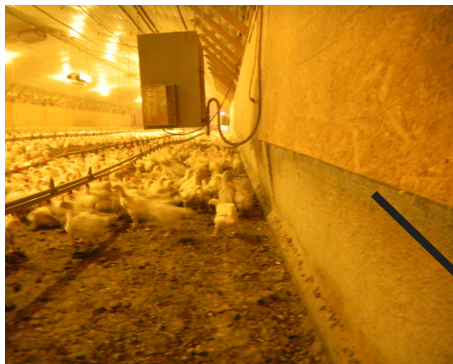
Figure 11. Foundation cracking due to rotation/settling.

Cracking in a foundation wall is normally a sign of uneven settlement or wall rotation (Figure 11). Settlement is not an adverse characteristic of a structure, provided it is uniform or equal all around the structure and is not excessive. Unequal or differential settlement of a foundation can cause problems in the structure above and can

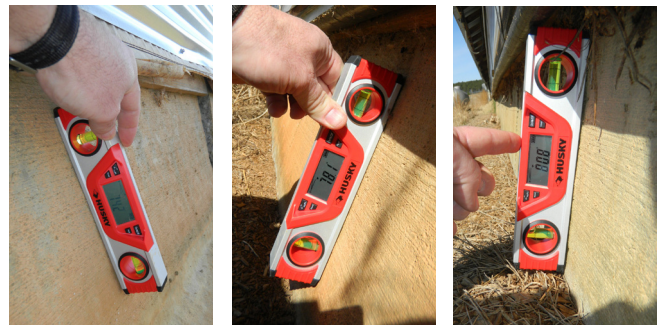
Figure 12. Measuring the angle of rotation of a concrete stem wall.

Rotation of the foundation wall is normally caused by poor soil conditions – either poor (sandy) underlying soil or poor grading around the structure (Figure 12). The following criterion is suggested:

Rotation of the foundation (degrees)	Suggestion
Less than 5 degrees	Not a major concern
5 to 10 degrees	Concern - Keep wall under watch. Consider adding soil around foundation and/or bracing the wall
Greater than 10 degrees	Structure should be examined by a professional and problems must be corrected

Remember that for a concrete stem wall some slope exists in the side of the walls even with no rotation. To determine how much that built-in slope is, measure the slope near the end wall of the house or at a point where no rotation has taken place, then compare it to the slope at the rotated section.

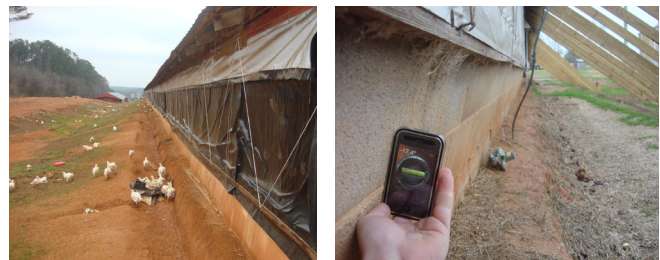
Figure 13. Rotation of concrete block wall foundation.

For block walls the above-recommended rotation should be reduced if vertical steel was not placed in the wall between courses (Figure 13). Without vertical steel the rotation of the structure is carried only by the mortar joint between block courses (Figure 14).

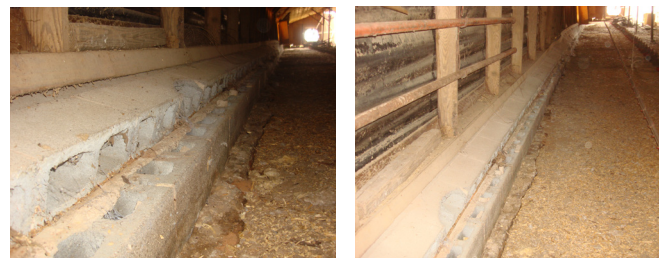
Figure 14. No vertical steel in concrete block side wall.

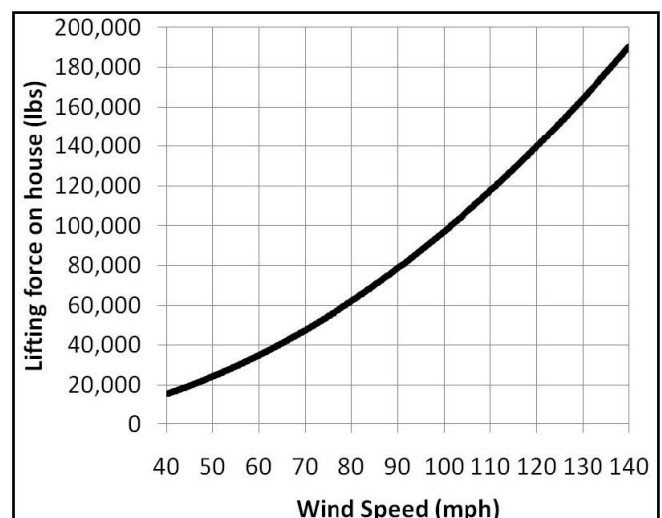
Figure 15. Lifting force on a typical 500-foot poultry house as a function of wind speed.

High winds moving over a poultry house roof can create powerful lifting forces that can pull the roof from the side walls or the side walls from the foundation. The lifting force on a poultry house is exponentially related to wind speed (Figure 15). That is, a doubling in wind speed can increase the lifting force four fold. For most areas of Georgia, poultry houses are supposed to be built to withstand a 90 to 100 mph wind without failure. For coastal areas the design wind speed is approximately 120 mph.

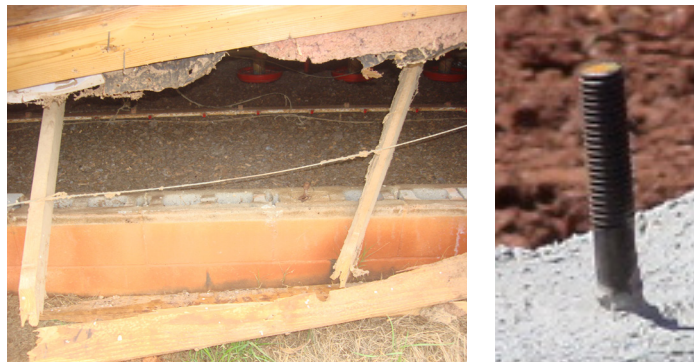
Figure 16. Cores of block should be filled intermittently and J-bolts installed to connect plates to the foundation.

In concrete block wall houses the sill plate should be periodically connected to the foundation through the use of anchor bolts or straps (Figure 16). The anchor bolts or straps must be placed not less than 4 in. and not more than 12 in. from the end of each member making up the sill plate. In concrete stem wall houses, the stem wall is essentially the foundation and as a result the sill plate should be connected to the stem wall through the use of “J bolts” positioned every 8 to 10 ft.

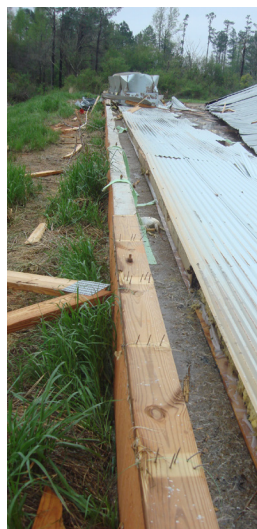
Figure 17. Nails loaded in withdrawal allowing pullout.

Where wall framing is not continuous from the foundation sill to the roof, members should be tied together to ensure a continuous load path. The vertical members (i.e., sill plate, wall studs, truss plate) in the wall must be positively connected together through the use of lumber, straps or clips. It is important to realize that nails loaded in withdrawal (driven into the end of the studs through the bottom plate) are not sufficient to provide this positive connection in high wind conditions (Figure 17).

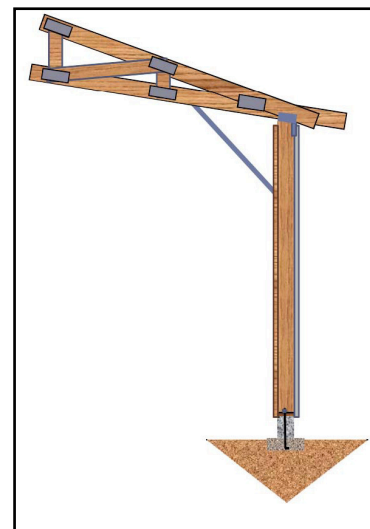
Figure 18. Example of side wall with a continuous load path.

Figure 18 illustrates an example of a side wall where there is a continuous load path. The sill, block wall and foundation are tied together through the use of a J-bolt and a filled concrete block core. The studs are connected to the sill by the exterior sheet metal and the interior plywood. The truss and the truss plate are tied to the side wall through the use of a “hurricane strap,” thus forming a continuous load path from the truss to the foundation. Figure 19 shows a curtain-sided house where the bottom curtain board/ exterior side wall metal is nailed to both the sill plate and the side wall members, thus tying together the lower portion of the side wall.

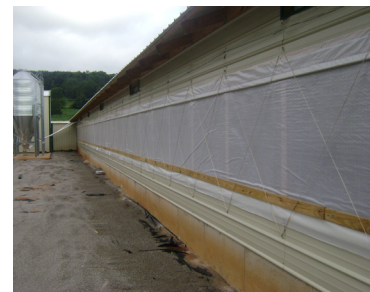
Figure 19. Sill plate connected to stud wall using sheet metal/lumber.

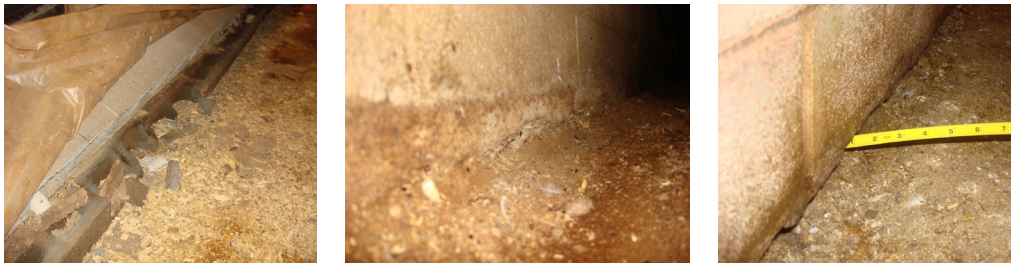
Figure 20. Erosion of block caused by manure.

Concrete block walls can be degraded by the ammonia in litter. Litter has a higher pH than concrete and also contains salts and moisture. Continuous exposure to manure can reduce the strength of concrete. A precipitate layer forms on the block surface because of the manure, reducing the strength of the blocks and decreasing the cracking strength of the blocks (Figure 20). In some cases the blocks can be eroded by the presence of the litter against the block wall. Block wall foundations must be inspected for erosion of the block. If sufficient damage to the block wall occurs, then the block wall must be replaced or repaired.

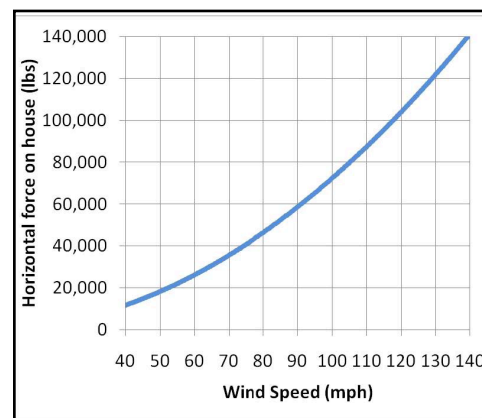
Figure 21. Horizontal force on a typical 500-foot poultry house as a function of wind speed.

In addition to lifting forces, winds can also generate lateral forces that can push a house over. The lateral wind loads, like the lifting loads, increase exponentially with wind speed. A 40 mph gust can generate 10,000 pounds of force trying to push a poultry house over (Figure 21). In a poultry house, lateral forces are transmitted down through the truss to the walls and then the foundation through the use of knee braces (Figure 22). The knee braces eliminate rotation at the truss to wall connection points and increase the ability of the wall section to carry vertical loads. The knee braces are needed to prevent excessive lateral movement. While knee braces may not be required on each truss, knee braces must extend over much of the house to carry these loads.

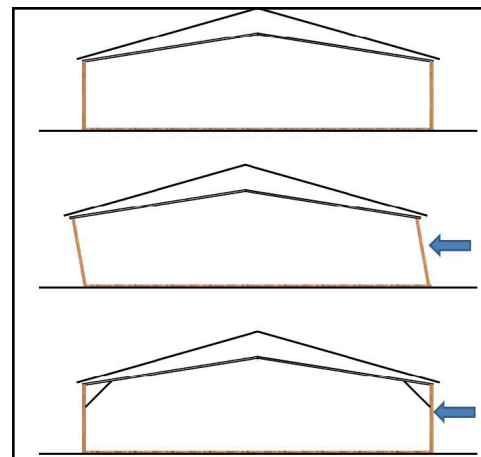
Figure 22. Knee braces provide support to resist sideways movement.

The truss wall system of a poultry house is an unstable mechanism without such bracing. Without this type of bracing, the walls of a poultry house are not built to withstand the lateral forces caused by winds.

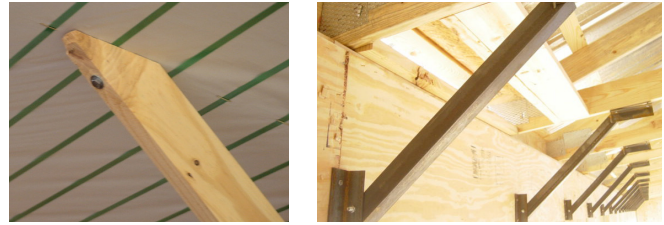
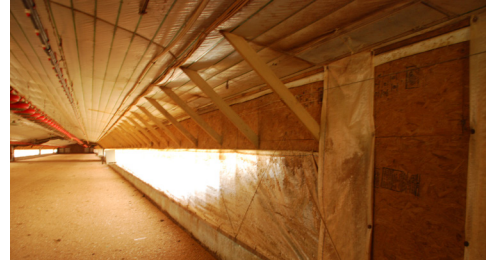
Figure 23. Knee braces.

Knee braces must be of sufficient size to carry the loads from the truss to the wall. Normally this might be 2x4 members or 1.5 in. x 1.5 in. angle iron. The connection between the knee

brace and wall must be sufficient to transfer this load. It is recommended that lag bolts be used to make this connection (Figure 23).

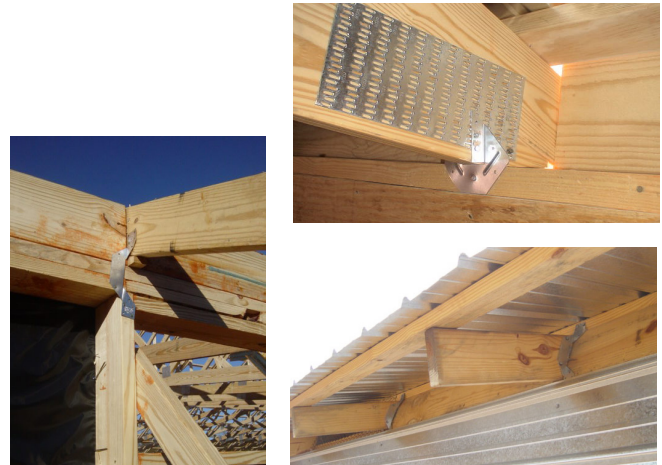
Figure 24. Trusses tied to the top of a wall using "hurricane straps."

The truss must be positively connected to the wall to prevent problems during up-lift caused by wind loads. Where wall framing is not continuous from the foundation to the roof, the members must be secured to ensure a continuous load path. The truss must be positively connected to the wall by straps, clips or connectors made of corrosion-resistant material not less than 0.040 inch in thickness (18 to 20 gage) (Figure 24). Nails loaded in withdrawal are not sufficient to provide this positive connection in high wind conditions.

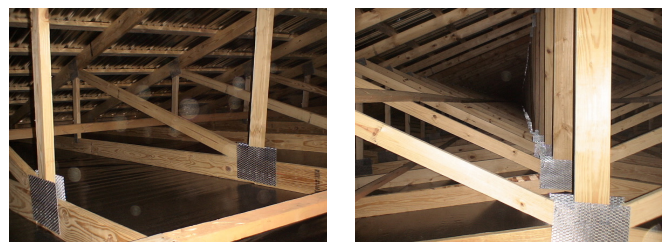
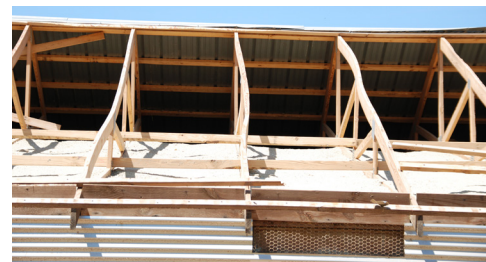
Figure 25. Bracing of trusses is essential to keep trusses vertical and to help carry loads along the length of the house.

1. The connector plates should be located on both faces of the truss.
2. The nails should be fully embedded in the member.
3. The members should be cut for tight-fitting wood-to-wood bearing at the joints.
4. The trusses must be braced such that they remain in a straight and plumb position (Figure 25).
5. Trusses must be handled with care during banding, bundling, delivery and installation to avoid damage.

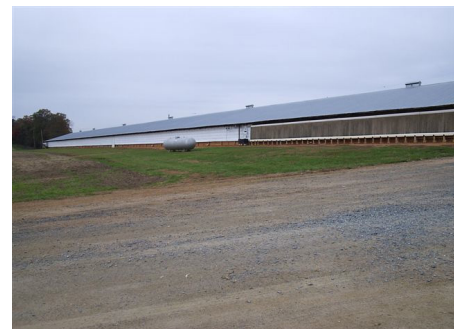
Figure 26. Poultry house with straight ridge line.

The roof line should be straight and horizontal inside and outside (Figure 26). From visual inspection of the house, if the roof line is not horizontal then a detailed inspection of the trusses and house must occur in the region of the house where this settlement has occurred (Figure 27). In that region the trusses must be inspected for straightness as well as any problems associated with truss plates, twisting of members, etc. The region to be inspected must extend a sufficient distance in both directions from the point where settlement has occurred to make sure no additional problems exist. Knee braces must be added in that region of the house if they are not already provided. If, during truss inspection, truss plates are found to be pulling out of the wood, trusses should be repaired using plywood gusset plates on both sides of the truss at the joint having problems. The roof should be inspected to make sure all the roof metal is adequately attached to the purlins and that no leaks occur in the roof. No sagging should be observed in the roof between trusses.

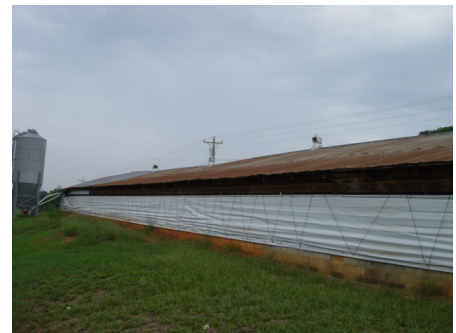
Figure 27. Poultry house with possible truss damage.
